Failure Mode and Endurance Tests of the HSST 100L System

Synopsis

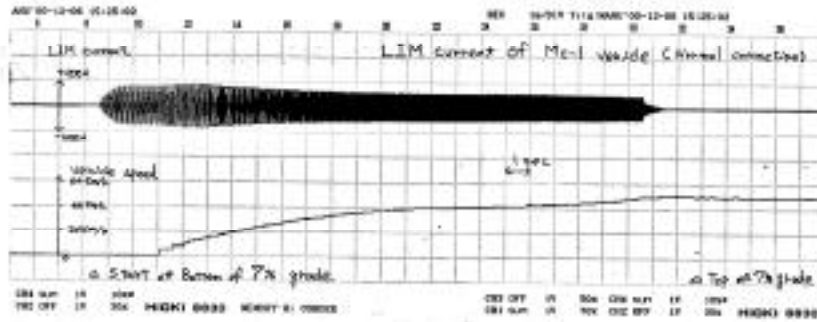
Typical LIM Input Current Traces (from LIM Failure Test)

LIM Admittance 100%

LIM failure test Date 09/Dec/06

Two tests were conducted with the LIM's on one side of the MC1 vehicle disconnected. The first test was conducted with the train started up from the bottom of the 7% gradient. 50 km/h was achieved at the top of the 7% gradient. The second test was done with the vehicle running from Tomeiko to Oye (refer to the test track shown in the appendix). 70 km/h was achieved. Traces of the LIM modulated input current were obtained which showed the LIM current at motoring, coasting and electrical braking modes. There was no instability nor excessive vibration found due to the imbalanced propulsion on the MC1 vehicle. It is noted that the installed power on board was sufficient in push/pull mode operation at 50 % degradation.
